NBSIR 84-2810

Performance Evaluation of Telephone Cable Pedestals in Underground and Atmospheric Environments

January 1984

J. L. Fink and E. Escalante

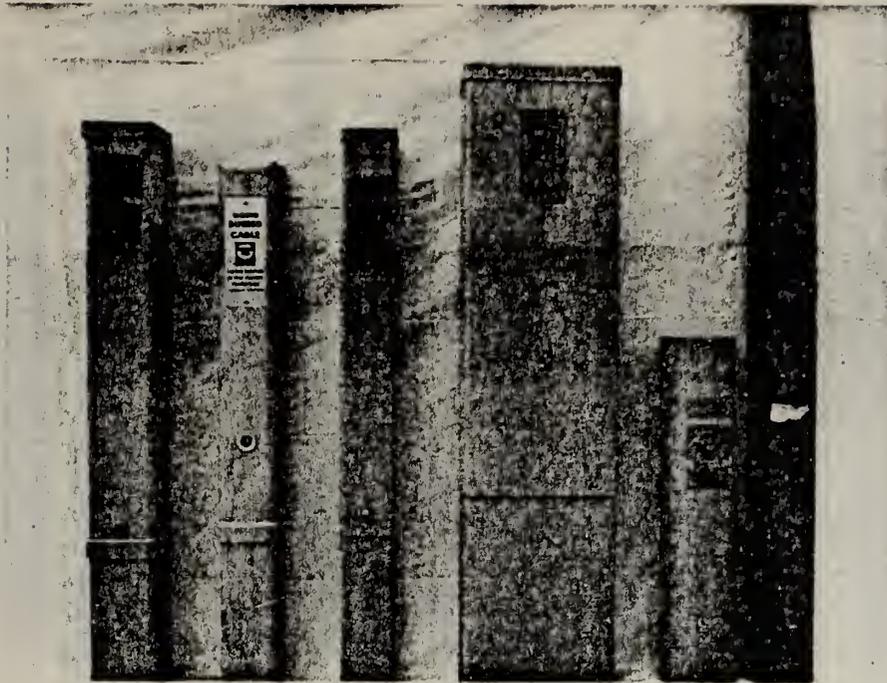
Figure 4. Systems 1,2,3,4,and 5, left to right. These pedestal specimens were considered unaffected by corrosion and/or degradation after exposure for one year at Site A.

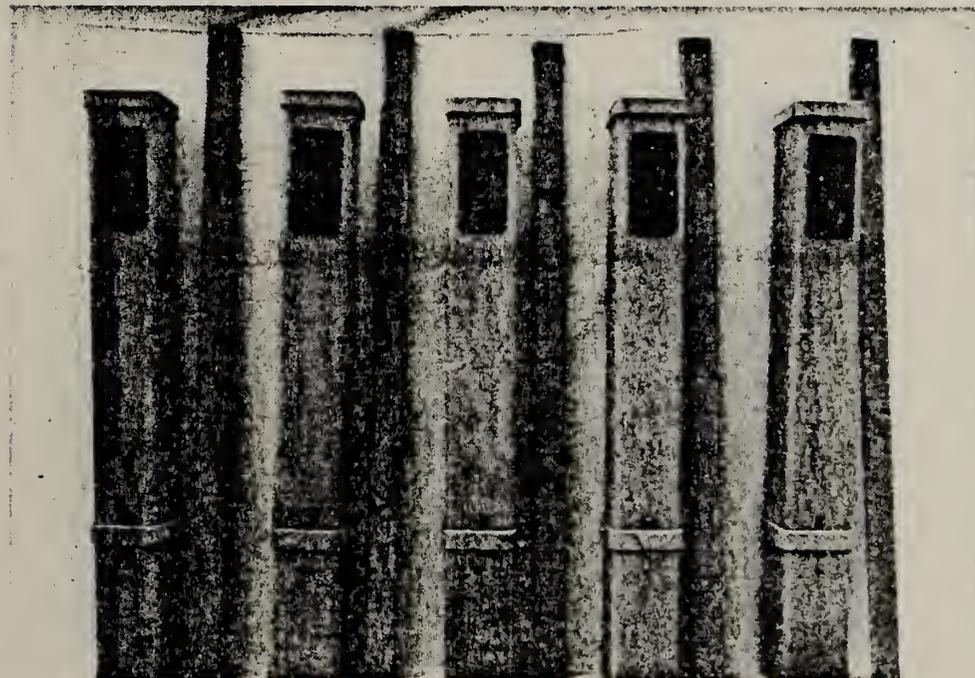
There was no degradation of the fiberglass surface on specimens of this system exposed for one year at Sites A, C, G, and H and for three years at Site B. The specimens exposed at Sites H and I for six years indicated slight degradation on the outside of the fiberglass cover plate. Slight to moderate degradation on the outside of the fiberglass cover plate cap was noted on the specimens exposed at Sites B, C, G, H, and I for six years. The specimens exposed at Sites B, H, and I for six years showed slight degradation of the fiberglass surface on the outside of the back plate above ground level. Slight cracking on the outside of the back plate above ground level was noted on the specimens at all sites exposed for six years.

Figure 5. System 1, Sites B,C,G,H, and I, left to right, exposed for six years. Moderate degradation of the fiberglass surface on the cover plate was observed on all specimens.

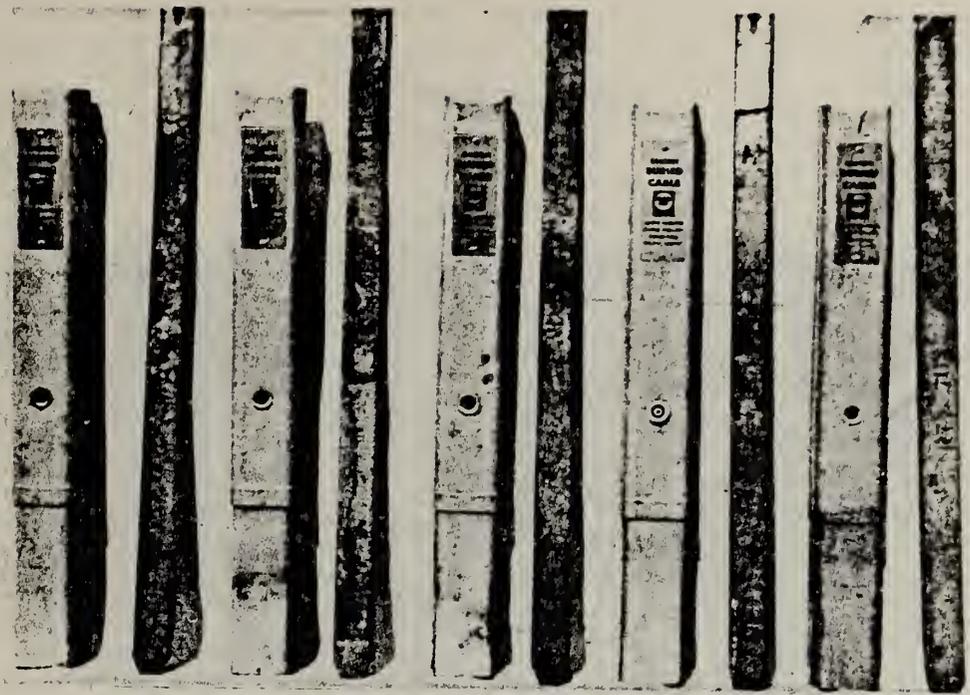
The pedestals exposed for one year at Sites A, B, G, and H showed little or no degradation of the fiberglass surface. Varying degrees of degradation were noted on the outside of the fiberglass cover plate, cover plate cap, and the back plate above ground level of specimens exposed for two, three, four and six years at Sites B, C and G. However, the most severe degradation was observed on the same regions after exposure for six years at Site H and on the cover plate and cover plate cap after exposure for six years at Site I.

The unpainted galvanized steel mounting stake showed little or no corrosion after exposure for six years at Sites H and I. Slight attack was observed on the galvanized steel surface of the mounting stake below ground level after six years of exposure at Site B, while slight dissipation and pitting was noted on the mounting stake after exposure for six years at Site C. Pitting due to corrosion of 0.001 in. to 0.005 in. and rust stain was found on the mounting stake below ground level after six years of exposure at Site G.

Figure 6. System 2, Sites B,C,G,H, and I, left to right, exposed for six years. Moderate to severe degradation of the fiberglass surface on the cover plate, cover plate cap, and back plate above ground level on specimens at Sites B,C,H, and I. Dark areas indicate corrosion of the mounting stakes at Sites C and G.

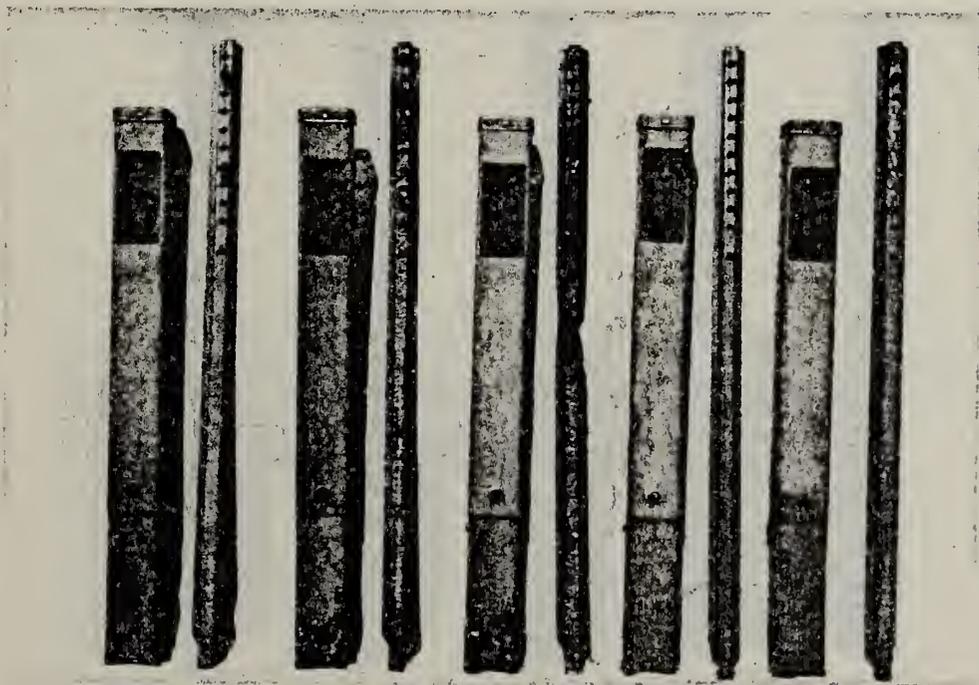
There was little or no corrosion of the painted galvanized steel surface on specimens of this system after exposure for one year at Sites A, B, H, and I. The specimens exposed at Sites B and H for two, three, and six years and at Site G for up to six years exhibited blistering of the paint on the galvanized surface on the outside of the cover plate cap at the area adjacent to the stainless steel rivets. However, specimens exposed at Site C for six years and at Site I for one, two and six years indicated blistering of the paint at the area adjacent to the stainless steel rivets on the inside and outside of the cover plate cap. The painted galvanized steel surface on the outside of

the back plate and ground cover plate on specimens below ground level showed blistering of the paint at the area adjacent to the stainless steel rivets at Site B after exposure for six years. Varying degrees of corrosion were noted on the painted galvanized steel surface on the inside and outside of the back plate and ground cover plate below ground level at Sites C and G after exposure for up to six years. The most severe corrosion was observed on the specimen at Site G after exposure for six years indicating slight dissipation of the galvanized steel surface where the paint had deteriorated from the surface of the back plate and ground cover plate above ground level. However, the same specimen examined at the same areas but below ground level exhibited dissipation of the galvanized steel surface with rust stain of 25 to 50 percent over that surface and pitting due to corrosion of 0.005 in. to 0.010 in.

The painted galvanized steel mounting stake on specimens of this system was unaffected by corrosion at Site B above ground level and at Site H above and below ground level after exposure for six years. Blistering of the paint on the mounting stake was noted on the specimens at Sites C and I above ground level and at Sites B and I below ground level after exposure for six years. Perforation due to corrosion was observed on the mounting stake below ground level for the specimen exposed at Site G for six years.

Figure 7. System 3, Sites B,C,G,H, and I, left to right, exposed for six years. Dark areas on specimens indicate corrosion on the mounting stake at Site C and the ground cover plate below ground level at Site G. Severe corrosion of the mounting stake below ground level on the specimen at Site G.

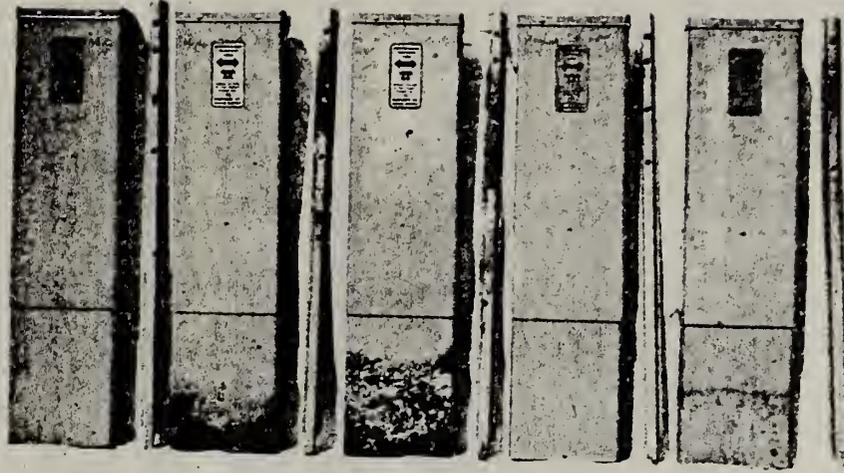
paint on the galvanized steel surface was observed on the outside of the back plate above and below ground level and for the ground cover plate below ground level for specimens exposed at Site H for six years. Specimens exposed at Site G for four and six years exhibited dissipation of the painted galvanized steel surface on the inside of the back plate and ground cover plate below ground level. The same areas of the same specimens developed rust stain over 25 to 50 percent of the galvanized steel surfaces and pitting due to corrosion of 0.005 in. to 0.010 in.

The painted galvanized steel mounting stake on specimens of this system below ground level exhibited pitting of 0.001 in. to 0.010 in. at Sites C and G after exposure for six years. The galvanized steel mounting bolts showed slight corrosion of the galvanized surface on the inside and outside of the pedestals at Sites B, C, H, and I after exposure for six years. However, dissipation and rust stain were indicated on the mounting stake bolts below ground level on specimens at Site G after exposure for six years.

Figure 8. System 4, Sites B,C,G,H, and I, left to right, exposed for six years. Dark areas indicate corrosion on the mounting stake and ground cover plate below ground level of the specimen at Site G. The warning sign on the specimen at Site I was not legible.

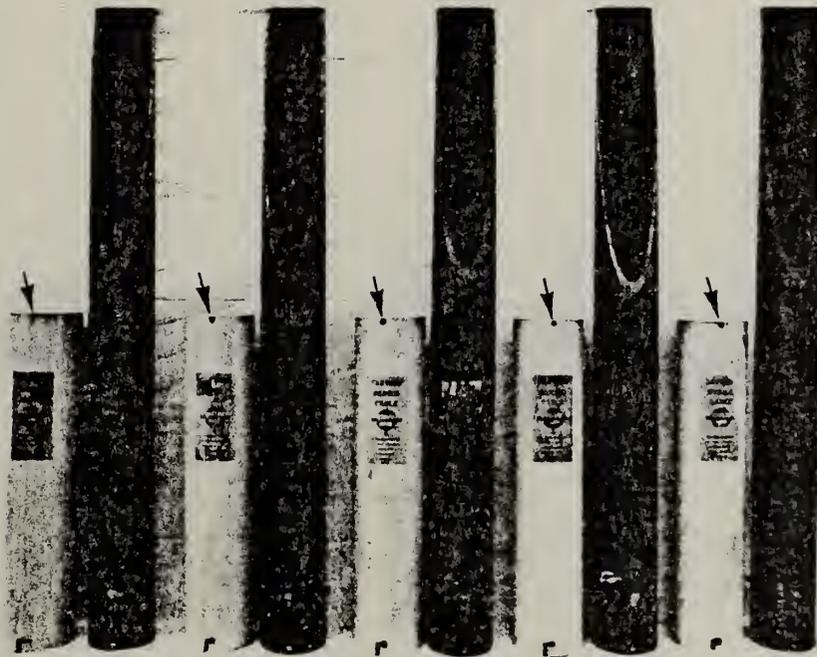
Figure 9. System 5, Sites B,C,G,H, and I, left to right, exposed for six years. Arrows indicate corrosion of the steel rivet on the cover plate cap on all specimens. Streaking of the fiberglass surface on the cover plate of specimens at Sites B,H, and I.

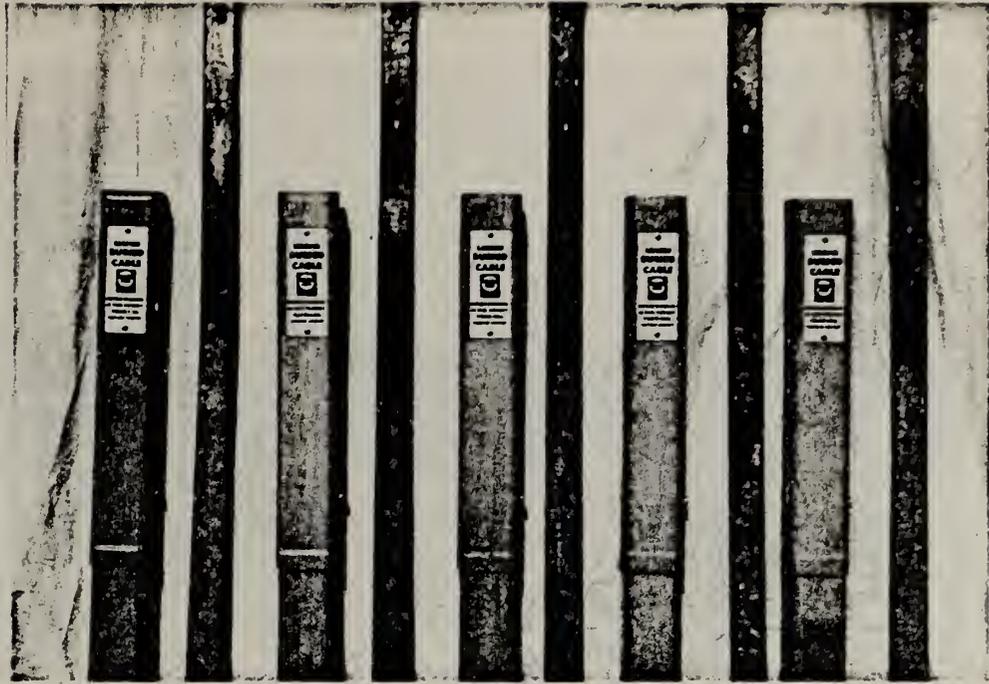
glass cover plate cap on specimens exposed for two years at Sites C and G, while moderate degradation was observed on the fiberglass surface of the back plate exposed for two years at Site C. The specimens at Sites C, H, and I showed slight to moderate degradation on the outside of the fiberglass cover plate after exposure for four years. Slight degradation was exhibited on the outside of the fiberglass ground cover plate and back plate above ground level for specimens exposed for four years at Site I, while slight degradation was noted on the back plate above ground level after the same exposure time at Site C.

The galvanized steel mounting stake below ground level showed slight attack and rust staining due to corrosion after four years of exposure at Site C, while the mounting stake at Site G exhibited dissipation and rust staining over ten to twenty five percent on the galvanized steel surface.

Figure 10. System 6, Sites B,C,G,H, and I, left to right, exposed for four years. Slight to moderate degradation of the fiberglass surface on the cover plate and/or cover plate cap on all specimens. Dark areas indicate corrosion on the mounting stake below ground level on specimens at Sites C and G.

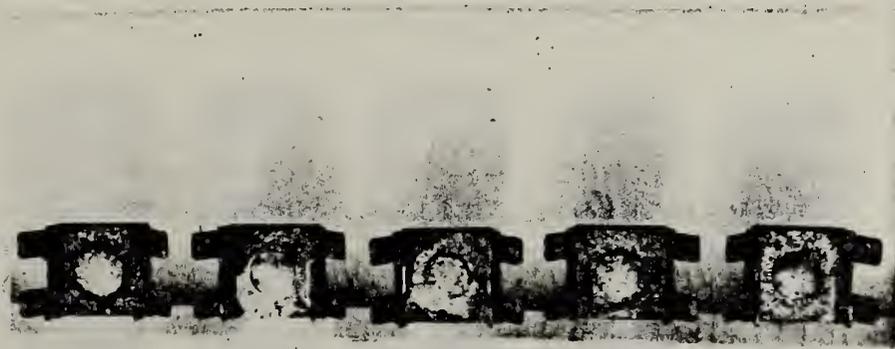
There was little or no corrosion of the pedestal hardware after exposure for one year at Site A, for up to three years at Site B, and for up to six years at Site H. Slight dissipation due to corrosion was noted on the plated brass connector plate on specimens at Sites B, C, G, and I after exposure for six years. The specimens exposed at Sites C and G for six years showed slight pitting on the connector plate to bracket hardware (an aluminum alloy rivet). Slight pitting was observed on the aluminum alloy bracket of specimens at Sites B, C, G, and I after exposure for six years.

Figure 11. Electrical connector plate and securing hardware of specimens from System 1, Sites B,C,G,H, and I, left to right, exposed for six years. Light areas indicate dissipation of the plated brass connector plate at Sites B and I, while the dark areas indicate the same at Sites C,G, and H. Light areas on the securing hardware (an aluminum alloy rivet) indicate slight pitting at Sites C,G, and I.

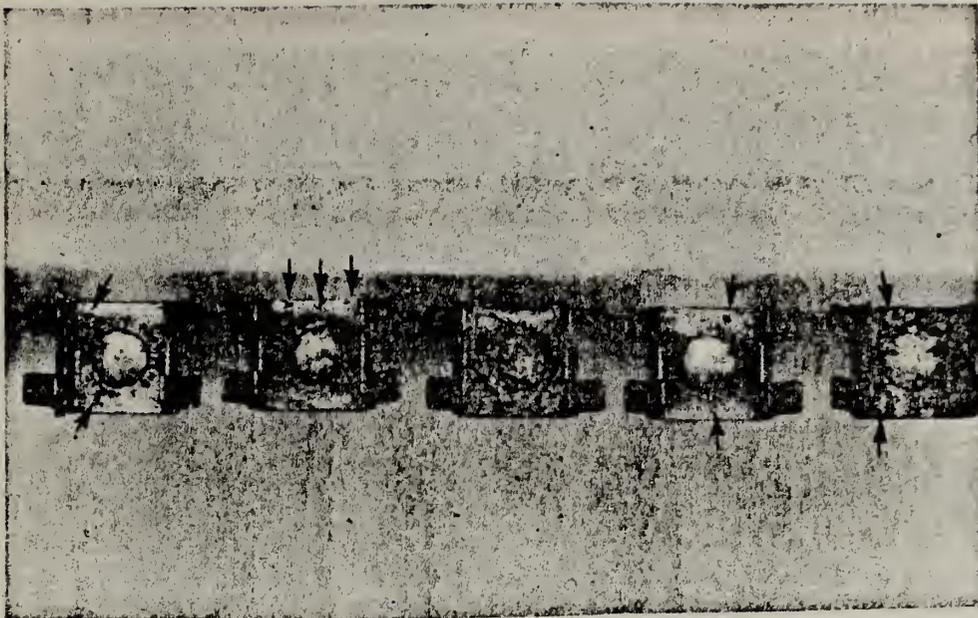
six years at Site H. The specimens exposed at Site C for two, three, four and six years, Site G for three, four and six years, and Site I for one, two, and six years showed slight localized pitting on the inside of the pedestal on the aluminum alloy hardware of the cover plate cap. Slight pitting due to corrosion was noted on the aluminum alloy rivets of specimens on the inside of the back plate above ground level after exposure at Site G for up to six years. Varying degrees of corrosion were noted on the steel clip of the locking retainer assembly on the inside of the pedestal exposed for four and six years at Sites B and C and for six years at Site H with the most severe corrosion on the specimens exposed for six years at Sites G and I.

Figure 12. Electrical connector plate and securing hardware of specimens from System 2, Sites B,C,G,H, and I, left to right, exposed for six years. Arrows indicate slight corrosion of the plated brass connectors of specimens. Light areas indicate pitting on the securing hardware (an aluminum alloy rivet) of specimens at Sites C,G, and I.

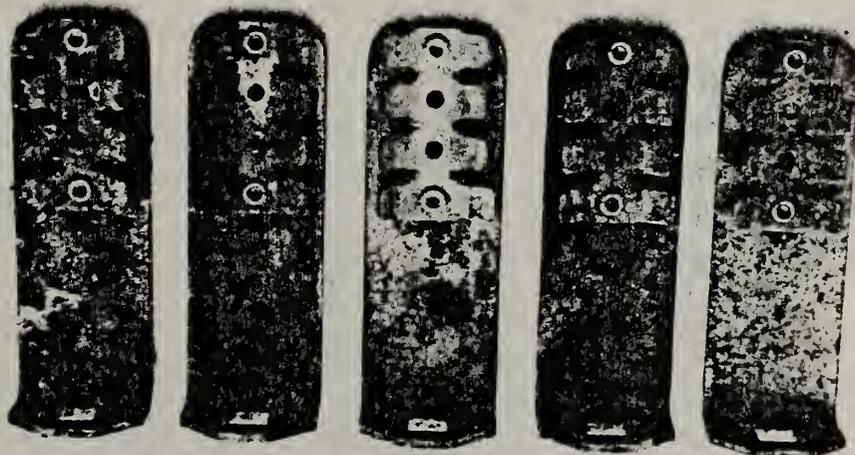
exhibited slight dissipation of the plating material on the plated brass connector plate. The plated steel bracket showed slight dissipation of the plated steel surface at Site B after exposure for two, three, four, and six years, while the plated steel bracket indicated corrosion and rust stain covering approximately 10 to 25 percent of the bracket surface at Sites C, G, and I after exposure for six years. The plated steel clip on the inside of the locking retainer assembly showed pitting due to corrosion of 0.001 in. to 0.005 in. at Sites B, C, H, and I after exposure for six years while the plated steel clip of the locking retainer assembly was severely corroded and considered destroyed at Site G after exposure for six years.

Figure 13. Electrical connector plate, securing hardware, and bracket of specimens from System 3, Sites B,C,G,H, and I, left to right, exposed for six years. Light areas indicate slight attack of the plated brass connector plate on specimens at Sites B,C, H, and I. Dark areas indicate slight corrosion of the plated steel bracket on specimens from Sites B,C,G, and I.

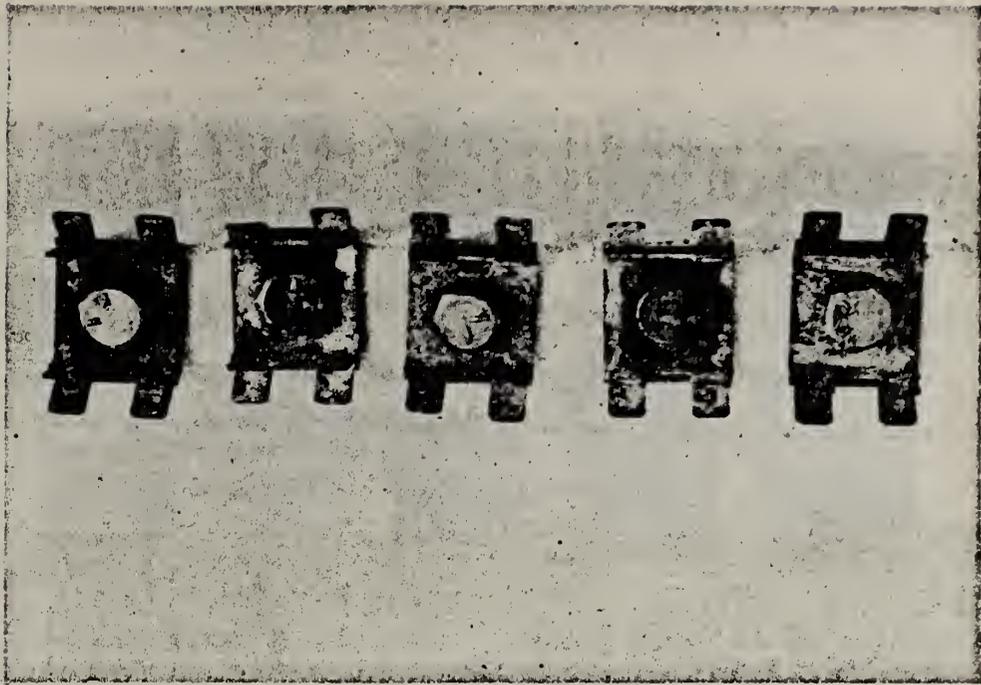
was observed on the plated brass connector plate for specimens exposed at Site B for three, four, and six years and at Sites C, G, H, and I for up to six years. The connector plate to bracket hardware (a stainless steel material) exhibited only superficial or no corrosion at Sites B, G, and H after six years of exposure. Slight attack was noted on the galvanized steel bracket on specimens at Sites C, G, H, and I after exposure for six years.

Figure 14. Electrical connector plate and securing hardware of specimens from System 4, Sites B,C,G,H, and I, left to right, exposed for six years. Light areas indicate slight dissipation of the plated brass connector plate on specimens at all sites.

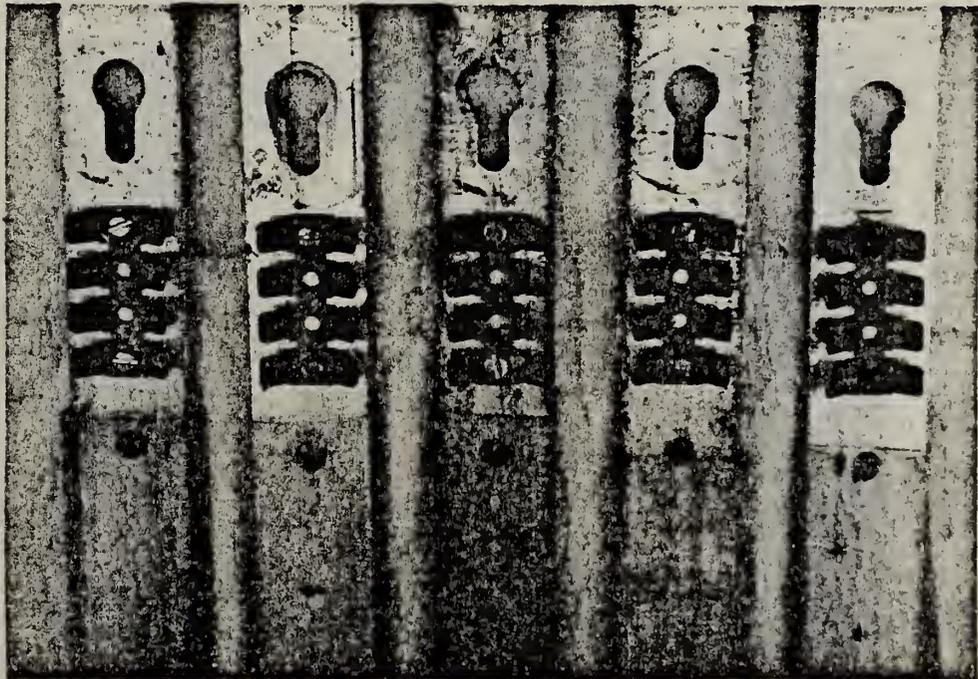
With few exceptions the pedestal hardware of this system was noted as having superficial or no corrosion. The steel rivets on the outside of the fiberglass cover plate cap of the specimens exposed for four and six years at Site B, six years at Site H, and one, two, and six years at Site I exhibited localized pitting due to corrosion from 0.001 in. to 0.005 in. in depth. The same hardware on the fiberglass cover plate cap of the specimens exposed for four and six years at Site C and six years at Site G showed severe pitting of 0.010 in. to 0.020 in. Slight dissipation was noted on the plated brass connector plate of the specimen exposed for six years at Site G. The connector plate to bracket hardware (a plated steel screw) showed rust and slight pitting due to corrosion on the specimens exposed for two, three, four, and six years at Site B. Slight pitting was observed on the aluminum alloy bracket of the specimens exposed for three, four and six years at Sites B and C and for six years at Site G. The bracket to back plate hardware (an aluminum alloy stud) exhibited slight pitting after exposure for four and six years at Site C. Slight pitting and rust stain was noted on the outside of the stainless steel locking retainer assembly of the specimen exposed for six years at Site G.

Figure 15. Electrical connector plate, securing hardware, and bracket of specimens from System 5, Sites B,C,G,H, and I, left to right, exposed for six years. Light areas indicate slight corrosion of the plated brass connector plate on specimens at Sites B,C, H, and I. Dark areas indicate slight corrosion of the securing hardware (a plated steel screw) on the specimen from Site B.

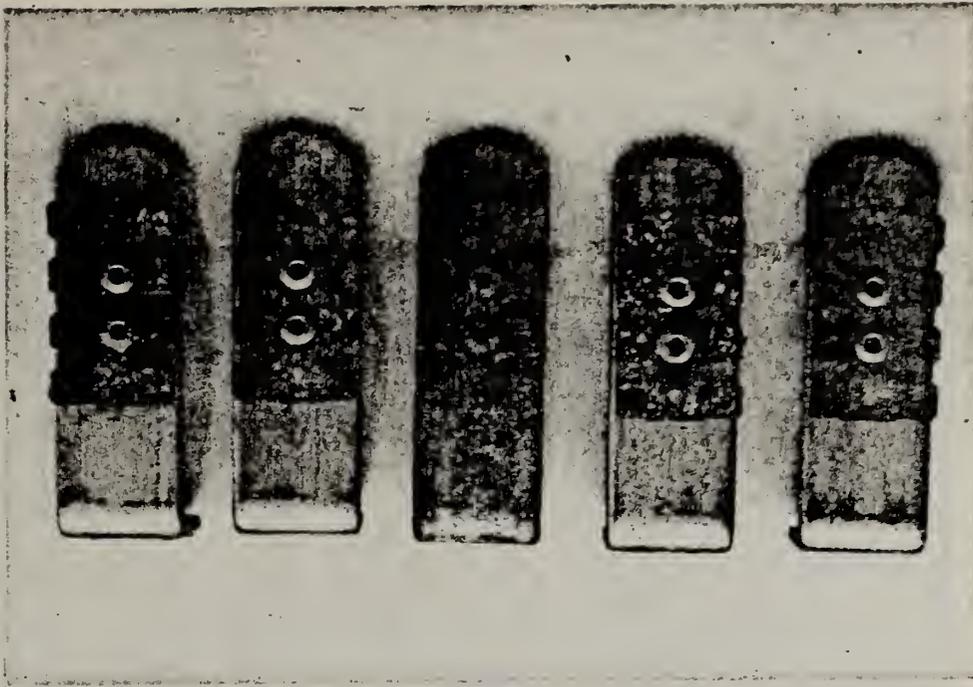
With few exceptions, the pedestal hardware of this system was noted as having superficial or no corrosion after exposure for up to two years at Sites B, G, and H. The aluminum alloy hardware on the inside of the cover plate cap exhibited slight pitting on the specimens exposed at Site C for two years and at Site I for one and four years. Slight attack of the plated brass connector plate was noted on specimens at Sites B, C, H and I exposed for four years. The aluminum alloy bracket on pedestals of this system developed slight pitting at Sites C, G and I after exposure for four years. Slight pitting and rust staining due to crevice corrosion was observed on the stainless steel locking retainer assembly on the inside of specimens at Sites C and G after exposure for two and four years.

Figure 16. Electrical connector plate, securing hardware, and bracket of specimens from System 6, Sites B,C,G,H, and I, left to right, exposed for four years. Light areas indicate slight attack of the plated brass connector plate on specimens at Sites B,C,H, and I. The light areas on the bracket (an aluminum alloy) indicate pitting on specimens at Sites C,G, and I.

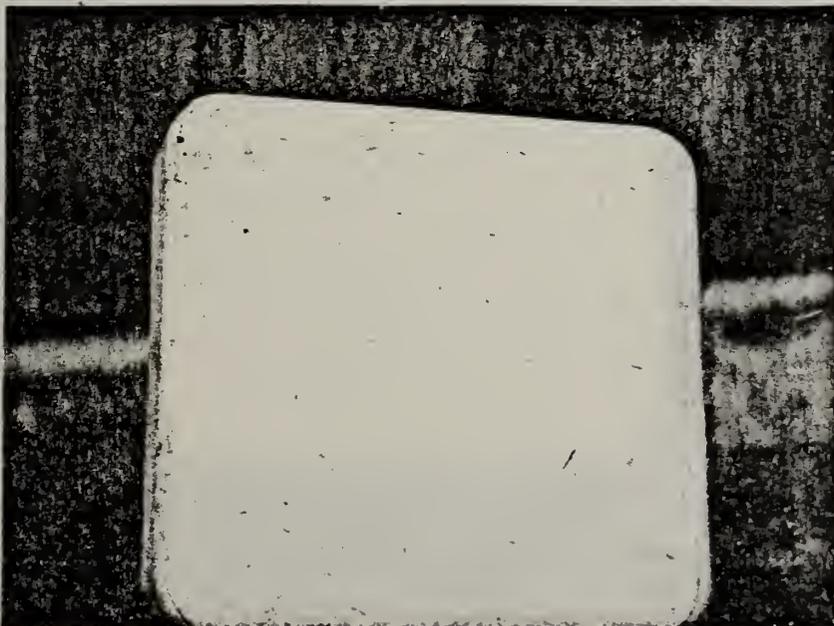
Figure 17. Top view of the cover plate cap of the specimen from System 1 exposed for six years at Site I. Severe degradation of the fiberglass surface. Light areas indicate strands of fiberglass standing out from the resin.

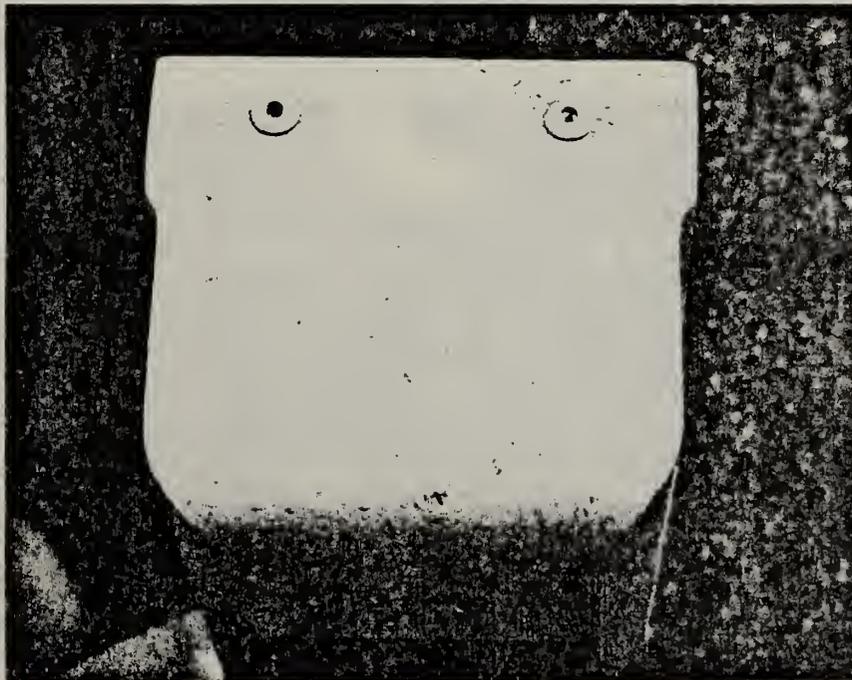
Figure 19. Top view of the cover plate cap of the specimen from System 2 exposed for six years at Site I. Severe degradation of the fiberglass surface. Light areas indicate strands of fiberglass standing out from the resin.

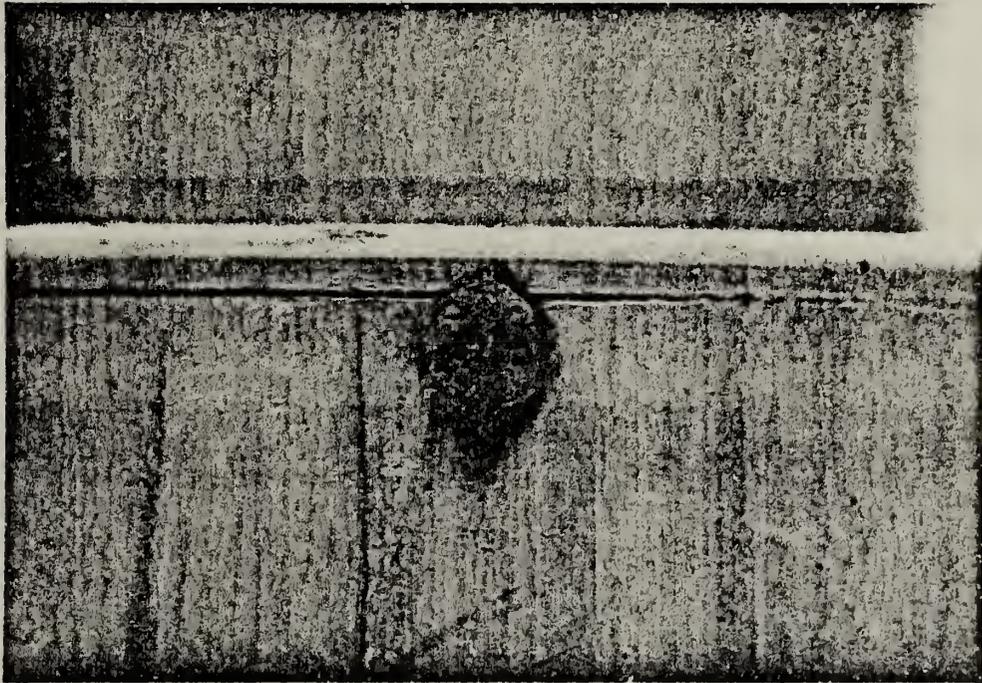
Figure 22. Steel rivet of the cover plate cap of the specimen from System 5 exposed for six years at Site G. Severe corrosion due to pitting can be observed.
